Project Title The Enclosure

Pemberton Heights, North Vancouver - British Columbia

Flashing Schedule

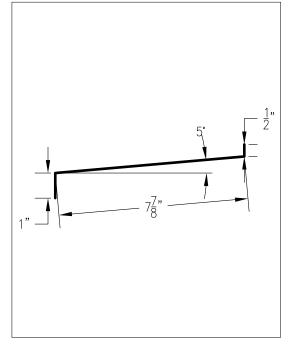
Base of Wall - 1st Storey Cover Board Clip/Bug Screen

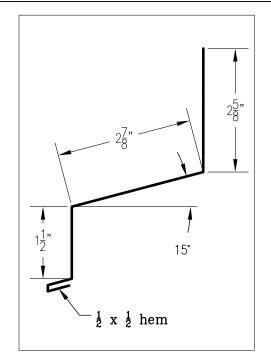
Base of Wall
Flashing - 2nd
Storey/Clerestory
